**NEW DATA CONCERNING THE ARCHITECTURE, WALL
PAINTINGS AND DATING OF THE LATE-MEDIEVAL
CHURCH OF ST. PETKA IN BALSHA, BULGARIA**

This article presents the outcomes of an observation and non-destructive survey of the semi-ruined late-medieval church of St. Petka in the village of Balsha in the Sofia region, as carried out by the authors of the article in partnership with Dr. George Bevan of Queen's University, Canada, and Dr. Miglena Raikovska of the New Bulgarian University. The project is an initiative of the Balkan Heritage Foundation, which also funded it. Making use of contemporary photographic techniques, the examination allowed us to further and deepen the available information on the architecture and wall paintings of the Balsha church, while the analysis of the collected data led us to reevaluate the arguments supporting its dating. While the nature of non-destructive surveying prevented us from making definitive conclusions about some of the questions concerning the history of the church, it also helped us generate new hypotheses that ought to be tested with conventional archeological research methods.

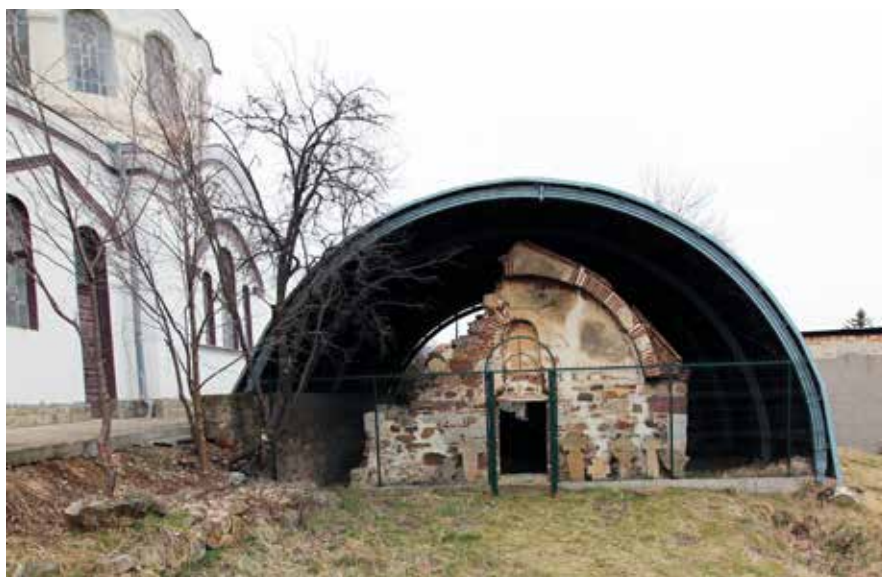
Fig. 3. The late-medieval church of St. Petka, western façade, center, and the modern church of St. Petka, left

The old church of St. Petka is a single-nave, barrel-vaulted building, with a rectangular plan, single semi-circular apse and a shallow arched projection of the vaulting on its western façade (Figs. 1,3,4). It has two architectural phases. Its collapsed vault and semi-ruined state might have been caused by damage to its roof following the abandoning of the building and/or burglary, or other fac-

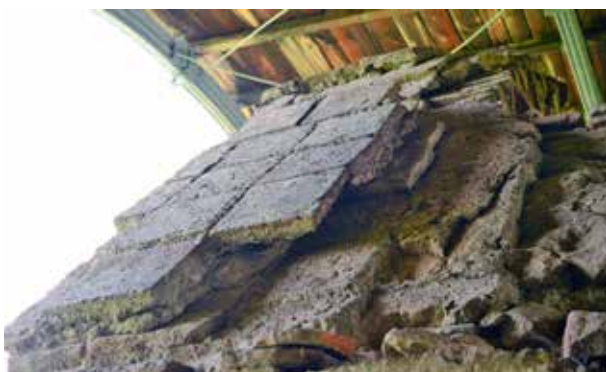
Fig. 5. Roof fragment above the southwestern corner of the church, 2017.

The building's original roof is missing, but extant fragments suggest that the vaulting was covered with a layer of mortar-bound stone-and-brick rubble that in turn served as the foundation for two layers of mortar-bound square bricks²³ that started from the cornice and followed the curve of the vaulting (Fig. 5). A surviving roof fragment above the western façade has an angular ridge, but the apex of the rest of the vaulting might well have been rounded. The quality of the bricks, the slope and the execution of the masonry, however, do not in any way suggest that this was the roof's top layer, as Miyatev and Vasileva have argued.²⁴ We believe it might have been covered with lead.

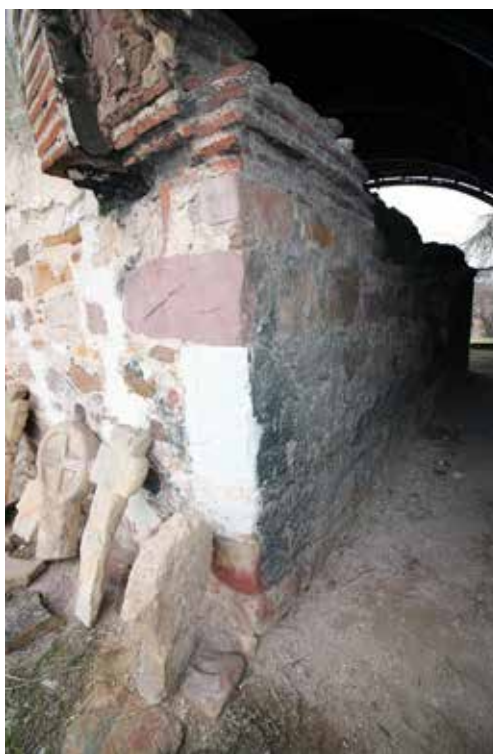
Fig. 6. Coinciding foundations of the walls of the church of St. Petka and the “western structure”, 2017.

The foundations of the structure located west of the church (Fig. 1) were first noticed by Dafina Vasileva and were excavated in 1986 by Romyana Pobornikova. Both scholars believed that they were part of a narthex added to the original church at a later point.³² Pobornikova mentioned a construction joint between the two structures but did not include a photograph to support her observation. Our own examination has led us to a couple of alternative hypotheses for these remains, which we have conditionally called “the western structure”. With these foundations, the building might have been a narthex, an exonarthex or even a small courtyard. Its walls were made of rough-cut stones (mostly sandstone) bound with white mortar. A socle of sorts, 0.15–0.4 m wide, makes up their substructure. The axes of the southern and northern walls of the western structure coincide with those of the church (Fig. 6). The surface and width of its southern wall also coincide with those of the southern façade. However, the northern wall of the western structure is 0.15–0.2 m wider than the northern wall of the church and seems to continue under its foundations. Moreover, the construction material used in the western structure is the same

kind, and even size, of stone used in the first, foundational row of the southern façade of the church. All of these observations have led us to theorize that the western structure might be an earlier building whose eastern foundations were used in the construction of the late-medieval church. Such hypothesis can only be tested with a carefully conducted subsequent archeological excavation. But for the time being, without rejecting Vasileva/Pobornikova's hypothesis, we are offering an alternative version of the construction history of the church.

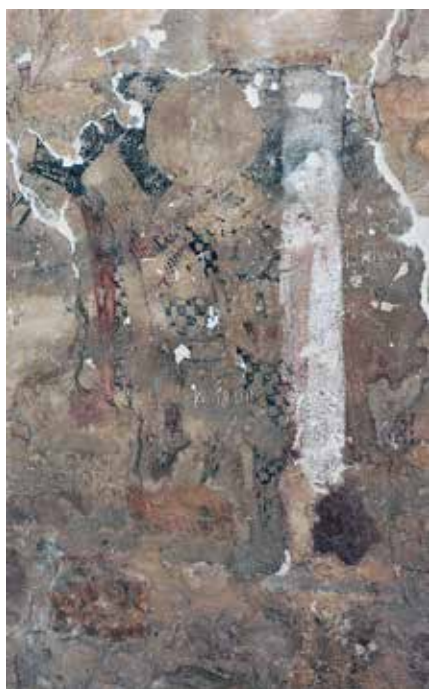
Fig. 7. Melismos. Fragment of the wall-painting in the southern part of the apsidal conch, 2017.

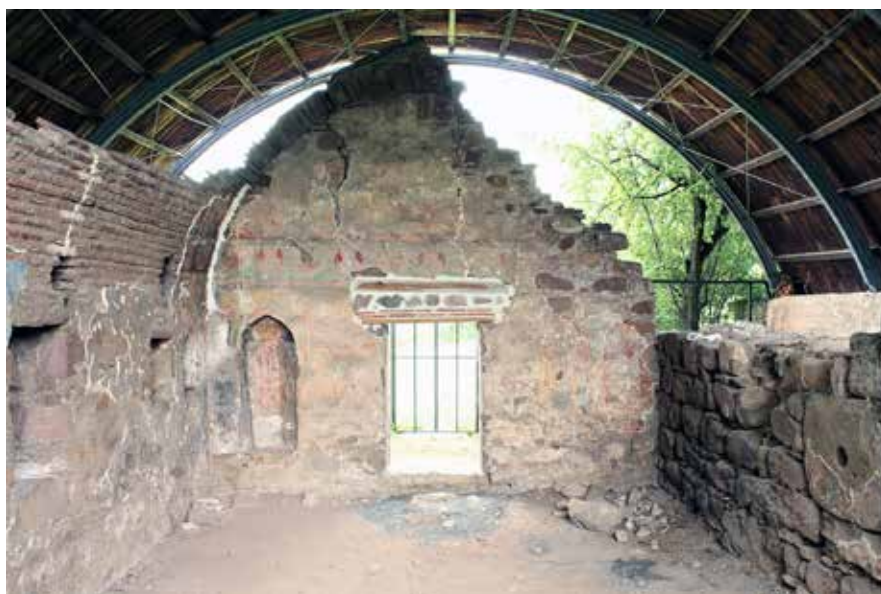
Fig. 8. Western interior wall, 2017.

The iconographic program of the western wall (Fig. 8) echoes that of the southern wall, beginning with an identical two-tier painted socle. The first section of the first register contains an image of a hermit saint. Next to it, above the niche, is the painted bust of another saint, while the area near the entrance has the traditional image of Archangel Michael (Fig. 9). Inside the niche is a depiction of the prophet Elijah (Fig. 2). The register continues northwards, past the church entrance, with representations of Sts. Constantine and Helena, and St. Panteleimon.³⁷ The reveals of the entrance door are decorated with crosses against a background of stylized vegetative motifs. The second register on this wall consists of a freeze of eight (of originally eleven) medallions, in varying degrees of preservation, depicting female martyrs. A representation of the Dormition of the Virgin Mary is situated in its middle. Traces of two other scenes can be seen on either of its sides, but their poor state prevents their identification.

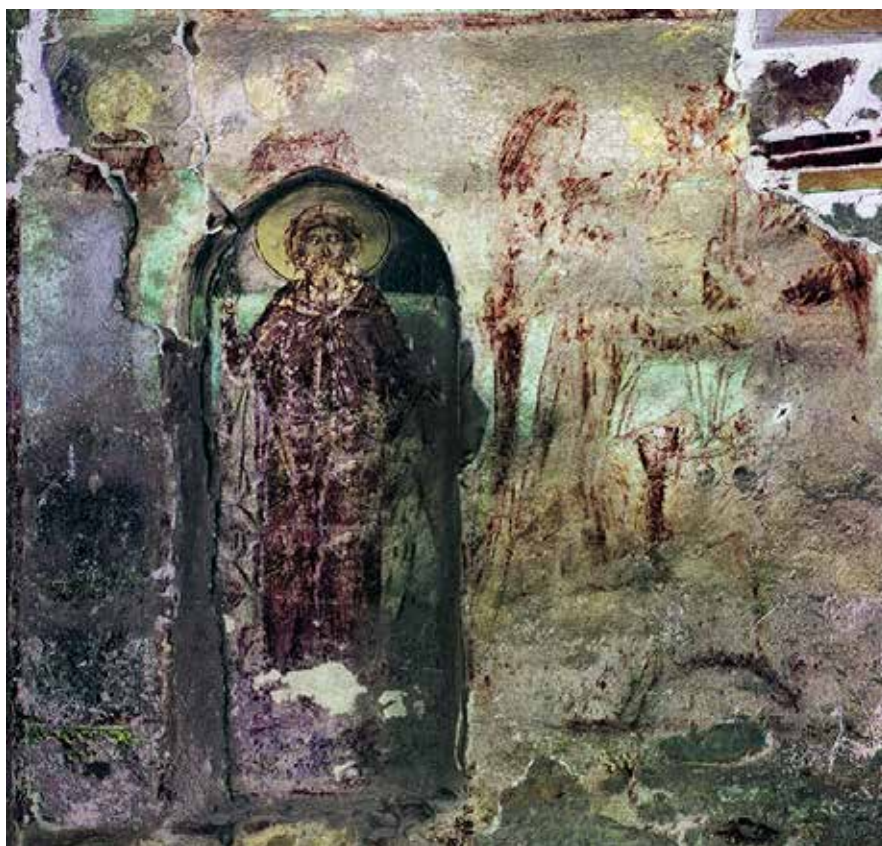
Fig. 9. Decorrelation stretched image of the faded wall paintings on the western interior wall (photo by George Bevan and Miglena Raykovska)

Foundation, in partnership with the New Bulgarian University and individual scholars such as Dr. George Bevan of Queen's University, Canada, used it as a site for its field school in graphic and photographic documentation of cultural heritage sites. In 2017, the church was the subject of a non-destructive archaeological survey led by the authors of this article, alongside Miglena Raikovska and George Bevan. Among other documentation, our team produced a photogrammetric model of the building, Reflectance Transformation Images of its surviving mural inscriptions, and decorrelation stretched images (Fig. 9) of the faded wall paintings.¹³
