*Giorgio Bezoari - Carlo Monti*

SURVEY AND STATIC CONTROLS OF THE SAN MARCO'S  
BASILICA IN VENICE

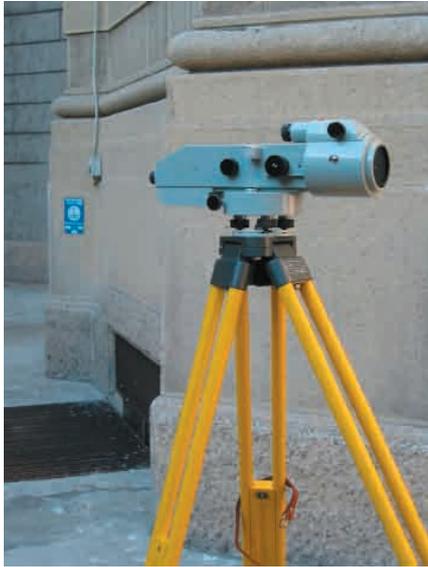
*Fig. 4 Automatic level Zeiss Ni1*  
Сл. 4 Аутоматска либела „Zeiss Ni1”

With regard to the measures of height variation, probably the most important method referring to the static control, the employed scheme was an high precision level, carried out with the automatic level Zeiss Ni 1 (fig. 4) and different rods, as we can see later.

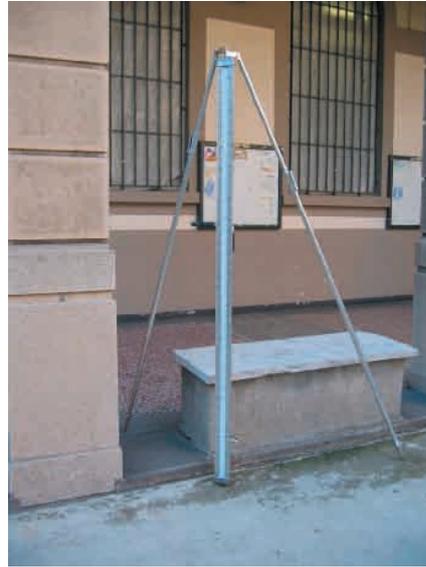
*Fig. 5 Rod with invar tape*  
Сл. 5 Летва са траком од инвара

- steel benchmarks on the ground floor: over these we put a rod with invar tape (fig. 5);
- benchmarks on the walls: composed by aluminium angular elements fixed on the walls and used with particular short rods (fig. 6);
- benchmarks composed by a steel bracket connected with a steel wire, stretched by a weight; in a particular position a little cylinder is fixed stopping a short rod (fig. 7).

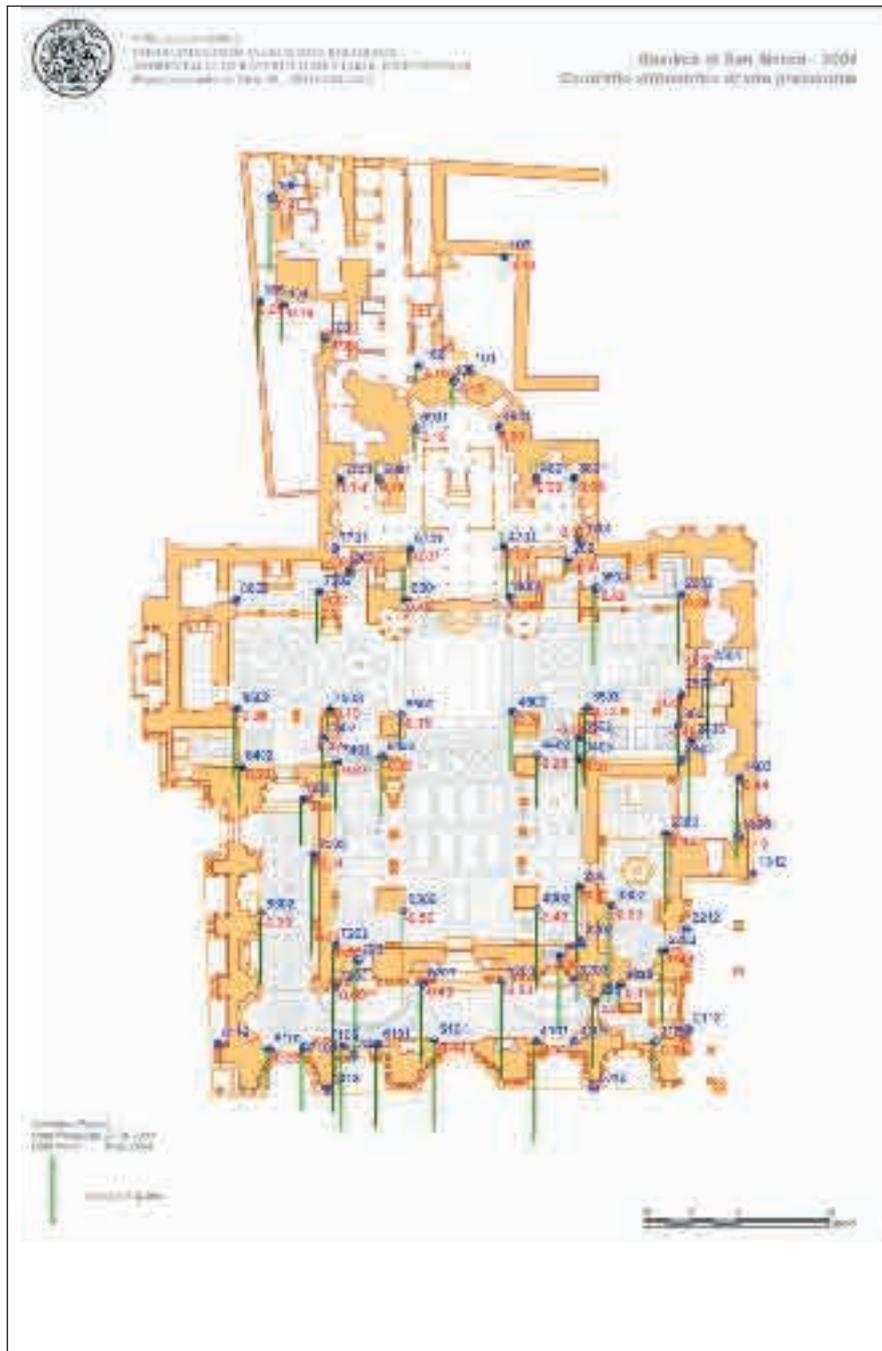
Fig. 9 Total variations  
 Сл. 9 Укупне варијације

The total variations, referred to the 1989 measure, are reported on figure 9, where it is interesting to see the behaviour of the 6601 bench mark that presents an irregular variation, probably due to a damage occurred in the past to the bench mark.
